# State of Utah

### Division of Oil, Gas & Mining

### Inspection Report

<b>Mine Name:</b> ML 27618	<b>Permit Number:</b> S/025/0025
<b>Operator Name:</b> Loy Crapo	<b>Inspection Date:</b> April 19, 2011
<b>Inspector(s):</b> Peter Brinton, Lynn Kunzler	<b>Time:</b> 2:00pm – 2:45pm
<b>Other Participants:</b> Loy Crapo, James Holland (BLM-Kanab)	<b>Mine Status:</b> Active

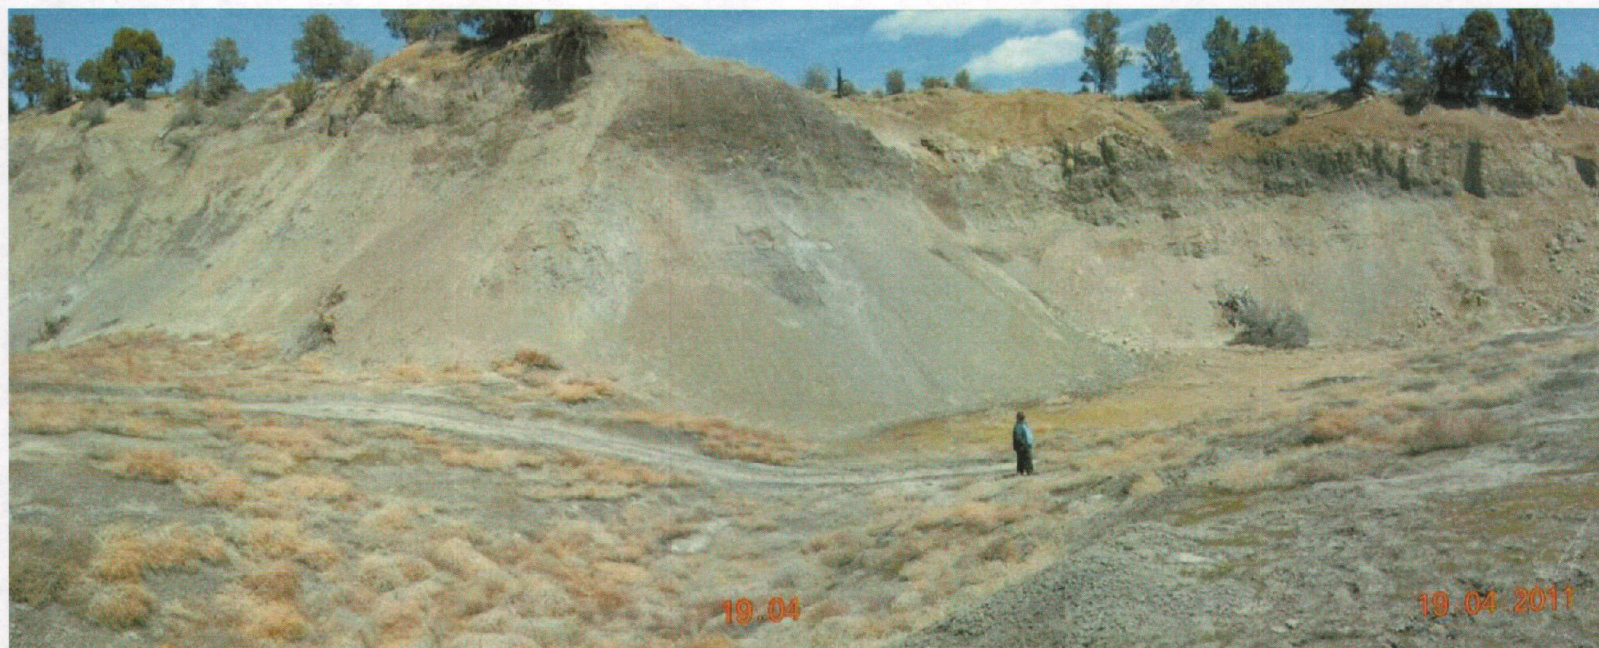
The depressions over the pits have been holding significant rainwater which originates above the highwall, and large amounts of storm water and snowmelt have flowed out of the depressions, resulting in a gully (up to about 10 ft deep) down the overburden slope. As a result, areas below the gully have received a lot sedimentation. Erosion will continue until the channel is stabilized. Some plants are growing on sediment deposited at the base of the slope in the gully.

Note the ponded water below the highwall and the top of the drainage channel running through the overburden to the lower left.

- 1) The angle of the overburden slope is decreased to a stable configuration in the slump area and in other adjacent areas where evidence of slumping is expected to occur in the future,
- 2) The erosion channel is stabilized, or some other acceptable water diversion plan is implemented to manage runoff and minimize future erosion, and
- 3) Revegetation has been established on recontoured areas.

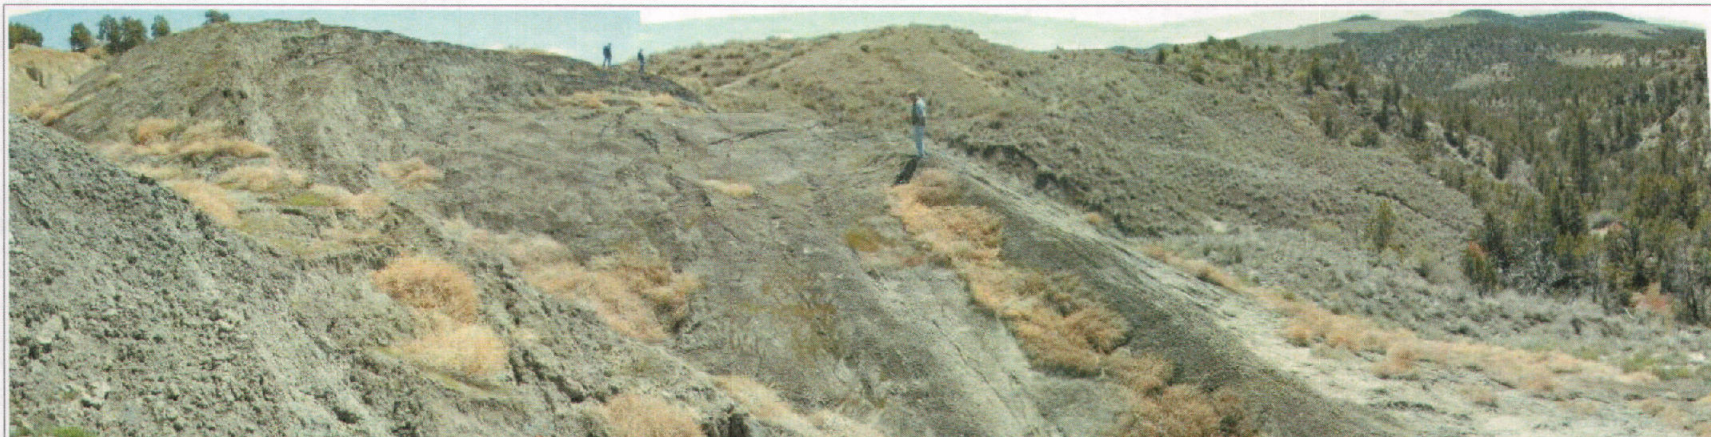
The area has received large amounts of precipitation, and a large part of the overburden dump has slumped down the canyon slope between fall 2010 and spring 2011. From crest to toe, overburden slope length down into the canyon was estimated to be about 150 feet, and the slope angle was between 30 and 38 degrees (measured using a clinometer). It is roughly estimated that the slump, about 100 feet along the contour and roughly 85 feet high or more, has dropped (on multiple failure surfaces) at least 15 to 20 feet vertically.

Side view of the slumping overburden and the gully running from the left down towards the bottom center of the photo. For scale, note the persons in the photo.

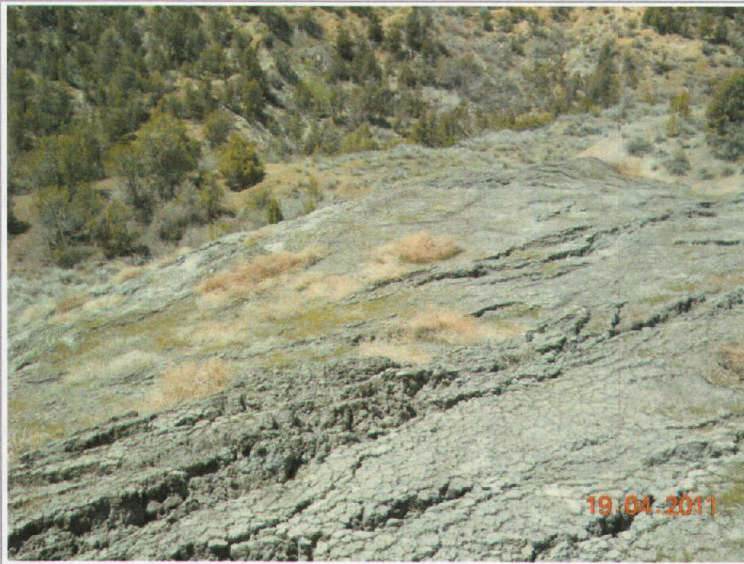
We also observed cracks (apparently fresh) at least 10 ft or so back away from the existing crest, an indication that the slopes may still be unstable, and may continue to slump with time and additional precipitation and without remediation. Tension cracks were also observed to the north and south of the active slump on areas that have not slumped, as well as in some reclaimed and revegetated areas to the south, and slumping in these areas may also occur over time.

Additional tension cracks on the overburden slope.

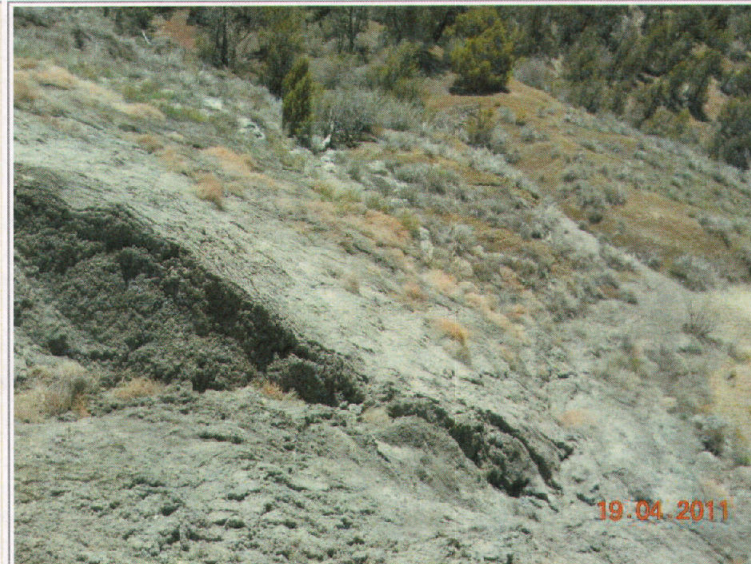
Eroding channel on the slope and sedimentation below it.

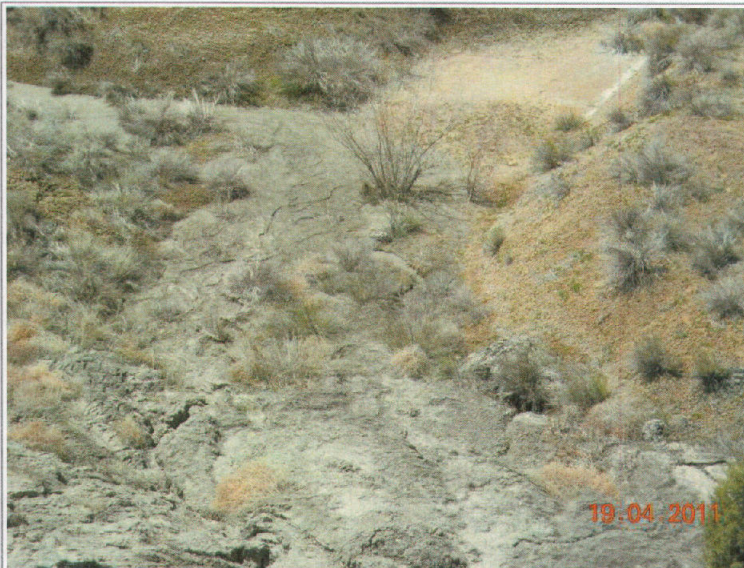
Sediment below the gully in the slump (note the vegetation on the sediment).

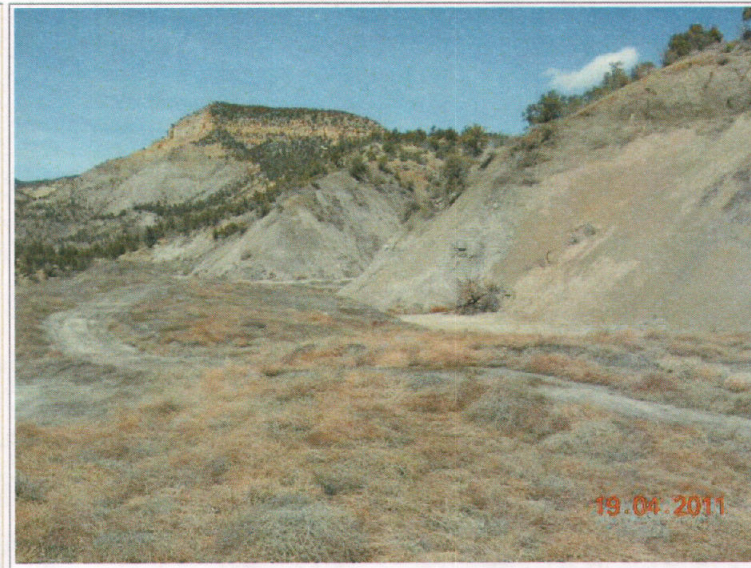
The highwalls appear to be mostly stabilized and blend in with the natural landscape. It is expected that they will be acceptable without additional work, and their stability can be re-evaluated in a future inspection. While the slumping overburden piles could be easily pushed down the slope, it is possible that some overburden may need to be pulled up the slope and placed against the highwall in order to achieve a stable and reseedable grade, and to avoid disturbing adjacent BLM land below the slump.

The highwalls blend in with the surroundings, and appear to be stabilizing.
